## Technical Guide

# Guide to Assessment and Repair of Flood Damaged Timber and Timber Framed Houses

(Revised 2<sup>nd</sup> Feb 2013)

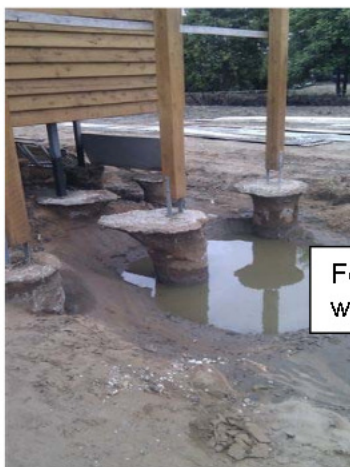
Footings scoured out by fast flowing water

**NOTE: Where fast flowing water has impacted on the dwelling, joists and bearers may have shifted/twisted and walls and windows may be out of square etc. Any excessive misalignment should be corrected before new cladding or lining is installed.**

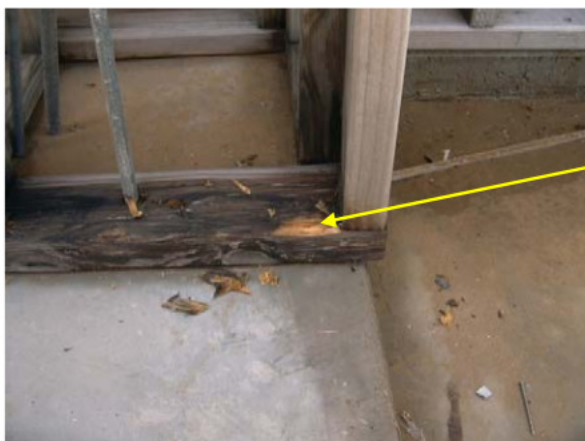
Although heavily discoloured with surface mould and blue stain, the pine timber is still sound as shown by scraping back the surface layer

If timber or wood based products remain damp or wet for prolonged periods and air (oxygen) is available, mould (dark staining) and eventually decay can occur, particularly in low durability timber such as untreated pine. Significant degradation or decay of timber is usually preceded by evidence of surface discoloration by moulds or stains, but if these are easily scraped off with a knife and the timber is sound underneath, it is not of concern. Degradation or decay in timber will be indicated if the wood has become soft and spongy or is easily penetrated with a knife or screwdriver.

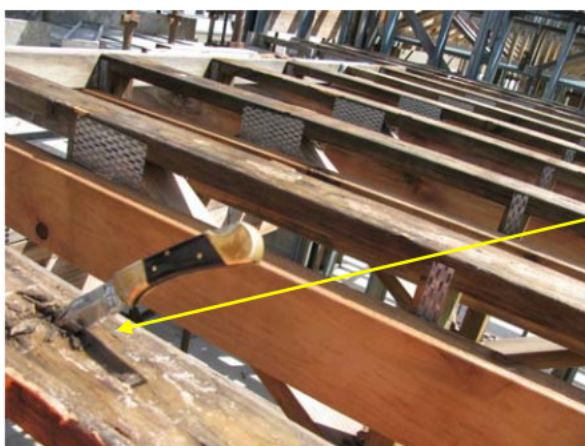
Decayed timber is soft and spongy and can easily be penetrated with a knife or screwdriver

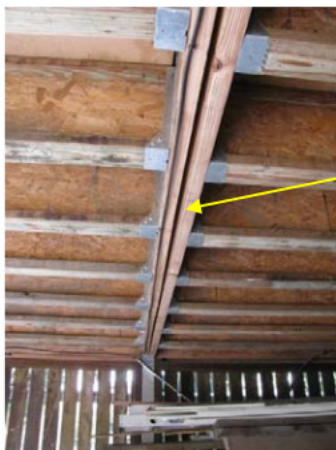
Expansion of the hardwood T&G floor above has caused the separation of double bearers.

Timber and wood based products that have been saturated will swell. When these products dry out they will shrink. The amount of swelling or shrinkage will be dependent upon the type and species of timber or type of wood product and time exposed to water. Where timber has swollen, such as in flooring, it may also have secondary effects such as cupping and pushing out external walls or movement of joists and bearers.

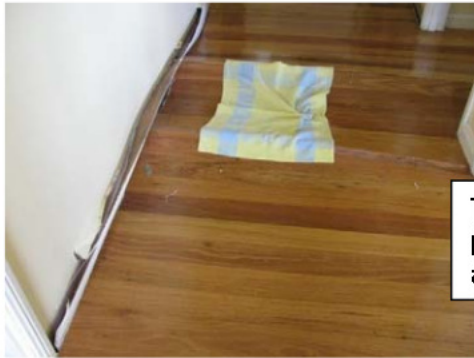
This inundated T&G floor over particleboard tented about 1 week after the water receded.

The flooring may continue to swell or expand across the boards for a period of time even after the water has subsided as moisture moves deeper into the timber. After cleaning, assess the extent of swelling and or tenting of boards (lifting off the supports). Check to see if there is still clearance between the edges of boards and the bottom plates of walls (usually under the skirting board) and to see if the flooring has expanded and started to push wall frames out at the bottom. If necessary relieve the pressure on walls by removing or cutting out perimeter boards. Eliminate any trip hazards that may have arisen due to tenting of boards or lifting of nails etc.
